SYSTEM 600 GENERAL MAINTENANCE AND ADJUSTMENT GUIDE

If you follow a routine maintenance schedule your system 600 will give you years of reliable service with a minimum of “down time”. This guide outlines the routine maintenance and adjustment techniques used to service this equipment.

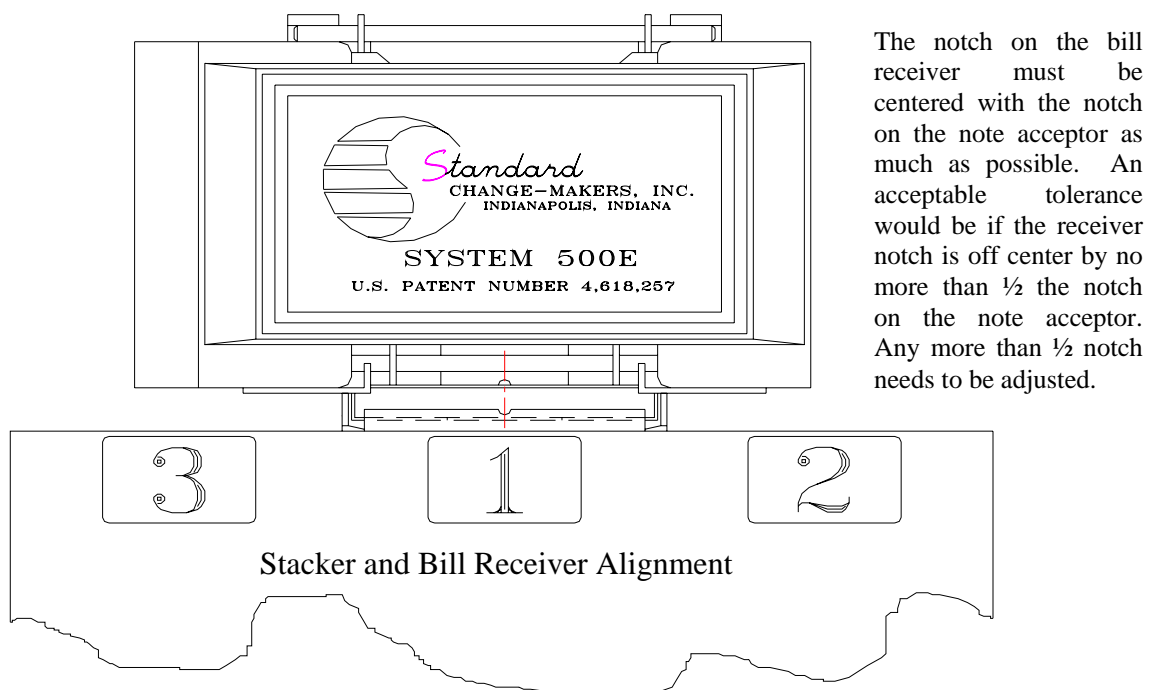
Figure 1

With the bill acceptor and stacker mounted in place, the stacker should be level and centered to the bottom of the acceptor as illustrated by Figure 1. The clearance between the bottom of the acceptor and the stacker should be less than 1/8 inch for maximum operation. Figure 2 illustrated the inspection point for this adjustment.

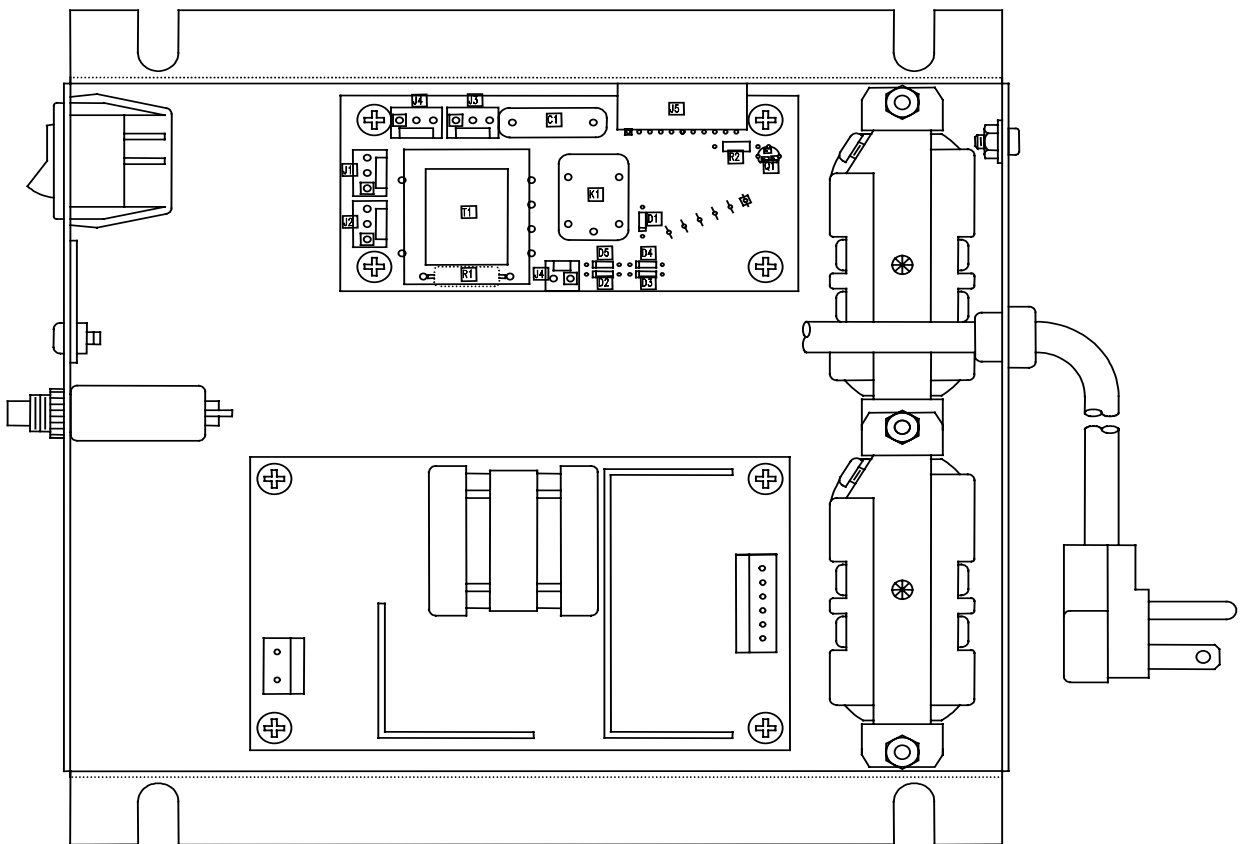
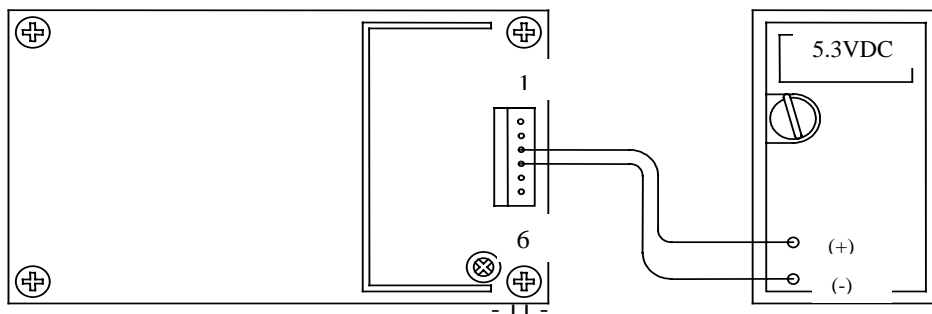
Power Supply- 40 Watt Board Adjustment

NOTE: The power supply is factory adjusted by a trained technician. However, if you have access to a volt meter, it's advisable to check the 5.35 DC voltage setting for accuracy. If required, use the adjusting pot to set the voltage between pin 3 and pin 4 to 5.35 volts. Improperly adjusted or "weak" supplies can cause "power fault" errors or poor bill acceptance.
